**PORT OF PALM BEACH DISTRICT
REQUEST FOR DISCUSSION AND
COMMISSION ACTION**

SUBJECT: **Request to Advertise for Proposals**
 Berth 1 Bulkhead Underwater Repairs

Subject: Port of Palm Beach Berth 1 - 2017 Above Water and Underwater Inspection

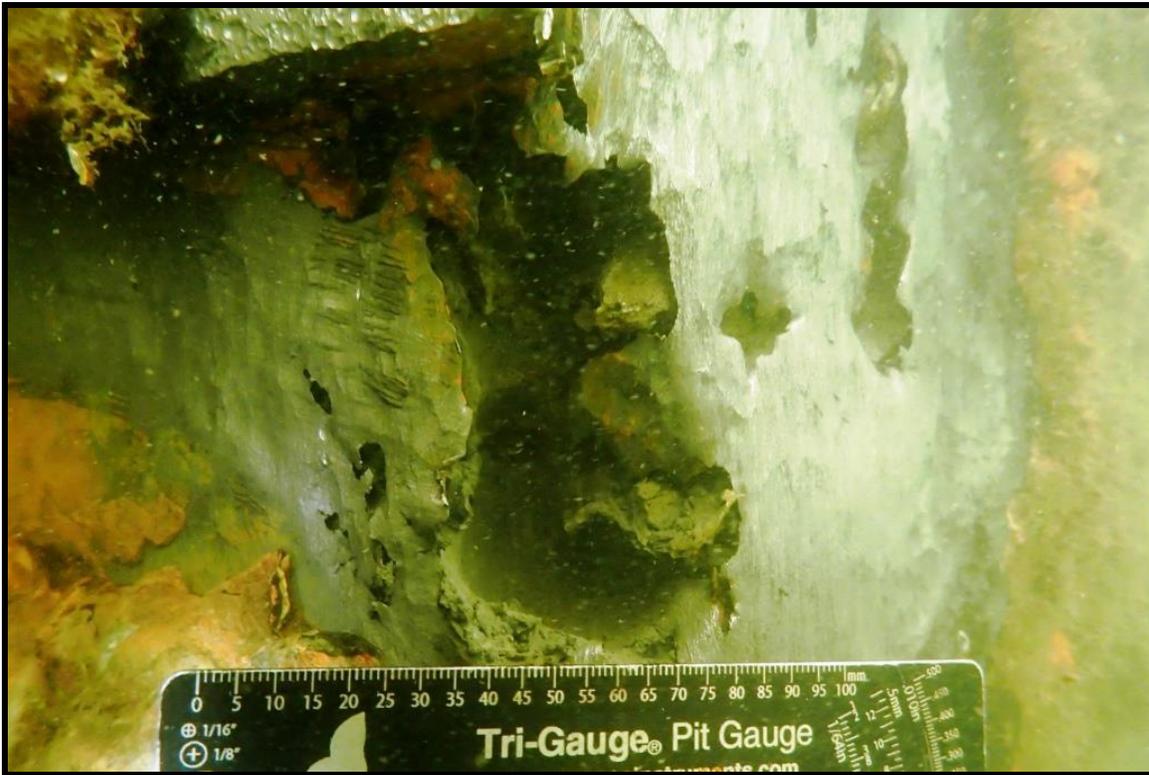
The PZ-27 steel sheet piling at Berth 1 is in overall Poor condition due to areas of severe pitting and overall thickness loss. The sheet piling typically exhibited 1/8 inch to 1/4 inch deep pitting throughout with pits measuring 1/4 to 1/2 inch in diameter. Isolated areas of severe pitting exhibited up to 3/8 inch deep pitting, including ten locations with 100% thickness loss (corrosion holes), and pitting up to 1 inch in diameter (Photo 1). A summary including the locations and dimensions of the corrosion holes is presented on Table 1.

Station	Description
1+50	Corrosion hole at -2 ft on outer flange that measured 12 in. high x 8 in. wide with heavy corrosion surrounding and active loss of backfill.
1+70	Corrosion hole at -2 ft on outer flange that measured 0.5 in. in diameter with heavy corrosion surrounding.
2+00	Corrosion hole at -2 ft on outer flange that measured 5 in. high x 1 in. wide with heavy corrosion surrounding and active loss of backfill.
2+00	Corrosion hole at -12 ft on outer flange that measured 0.5 in. in diameter with heavy corrosion surrounding.
2+18	Corrosion hole at -2 ft on web that measured 12 in. high x 5 in. wide with heavy corrosion surrounding and active loss of backfill.
2+48	Corrosion hole at -2 ft on outer flange that measured 0.75 in. diameter with heavy corrosion surrounding and active loss of backfill.
2+48	Corrosion hole at -2 ft on inner flange that measured 1 in. high x 2 in. wide.
2+48	Corrosion hole at -2 ft on outer flange that measured 1 in. diameter with heavy corrosion surrounding and active loss of backfill.

2+48	Corrosion hole at -20 ft on outer flange and web that measured 3 in. high x 2 in. wide with heavy corrosion surrounding and active loss of backfill.
2+40	Corrosion hole at -20 ft on web that measured 1 in. in diameter with heavy corrosion surrounding and active loss of backfill.

Photo 1. Station 2+48 corrosion hole in outer flange and web of steel sheet pile.

In the short term, the holes in the steel sheet piles are allowing loss of fill material and if allowed to continue severe undermining of the deck could result. Therefore the holes on the sheet piles should be repaired with welded steel plates within the next year with grout injections into the void areas. The missing ship fender should be replaced and the detached ship fender reattached to the face of the wharf within the next 12 months.

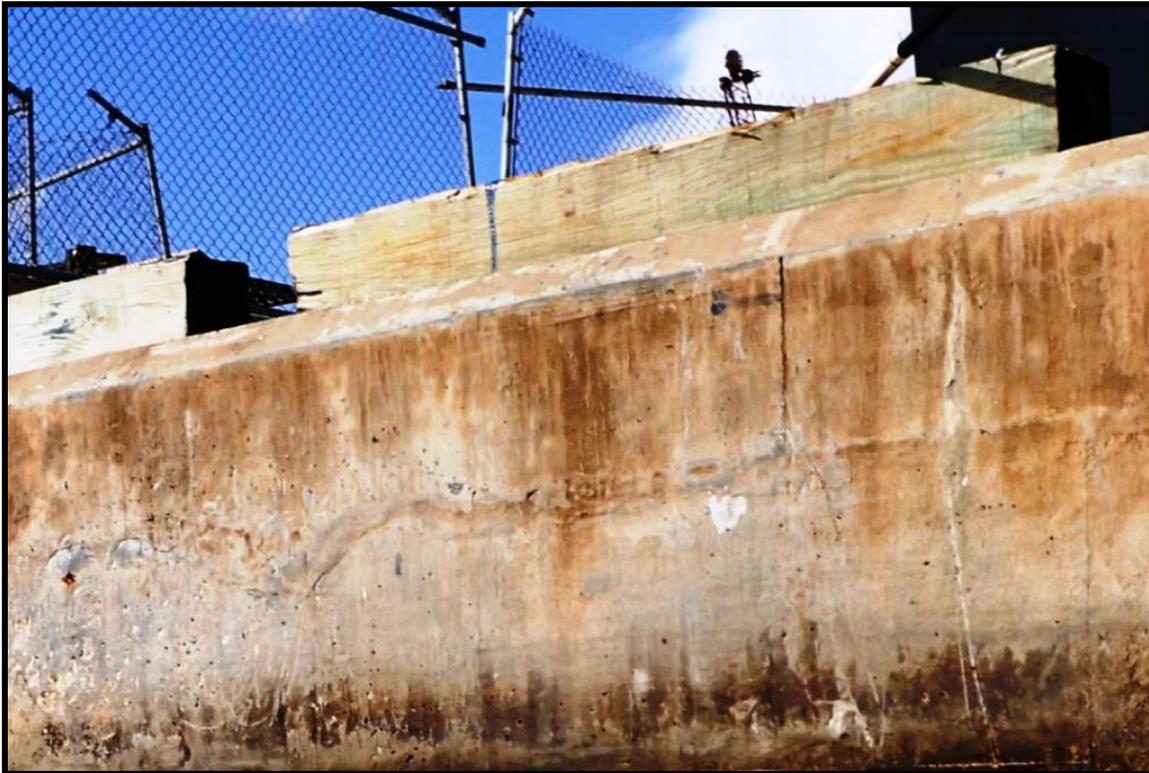
Additionally, the concrete pile cap has random 1/16 in. wide vertical cracks and a few localized areas of deterioration (Photo 2).

Photo 2. Station 3+85 Typical Concrete pile cap.

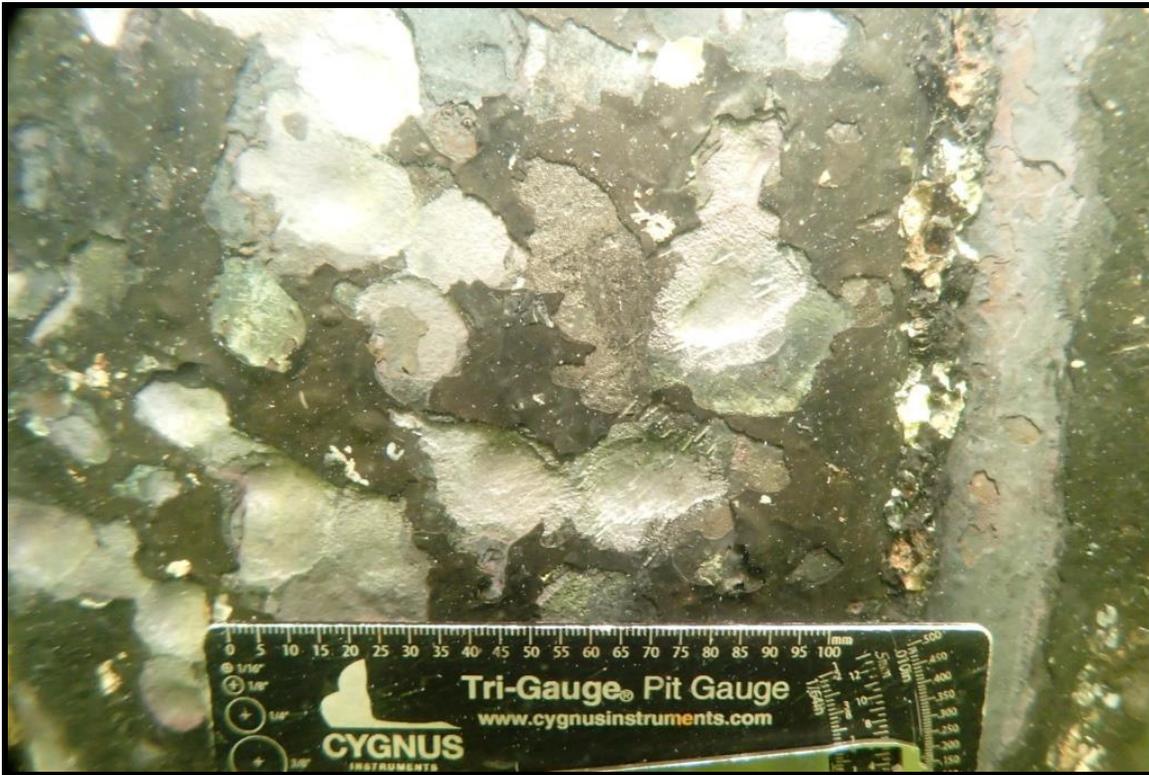
The steel sheet piles between station 4+25 and 4+95 are in overall Fair condition with only moderate deterioration. Minor to moderate pitting was observed along this portion of the berth (Photo 3). Typically the areas of pitting cover approximately 35% of the steel sheeting and measure 1/8 in. deep with a diameter of 1/2 in. Isolated pitting measured up to 1/16 in. deep and up to 1 in. in diameter.

Photo 3. Station 4+58 typical steel sheet pile with minor to moderate pitting.

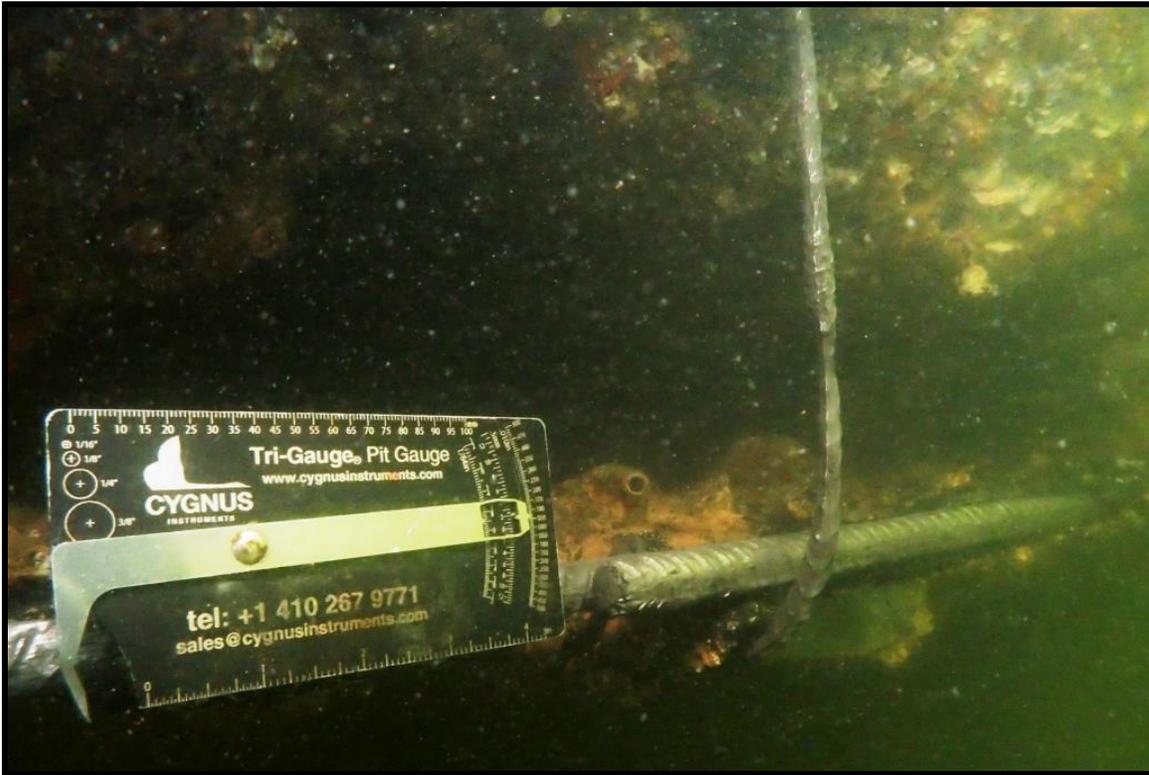
The concrete cap between station 4+25 and Station 4+95 is in overall Fair condition due to large spalls with exposed steel reinforcing between Station 4+40 and station 4+65 (Photo 4). Additionally the concrete pile cap has random 1/32 in. wide vertical cracks and a few localized areas of deterioration.

Photo 4. Station 4+55 Concrete pile cap with large spall and exposed reinforcing.

The H-Piles with severe flange loss should be repaired with welded steel plates within the next three years. The corrosion on the exposed steel reinforcing should be removed (cleaned) and the large spalls along the concrete pile caps from Station 4+50 to Station 4+65 should be repaired with formed concrete within the next 5 years.

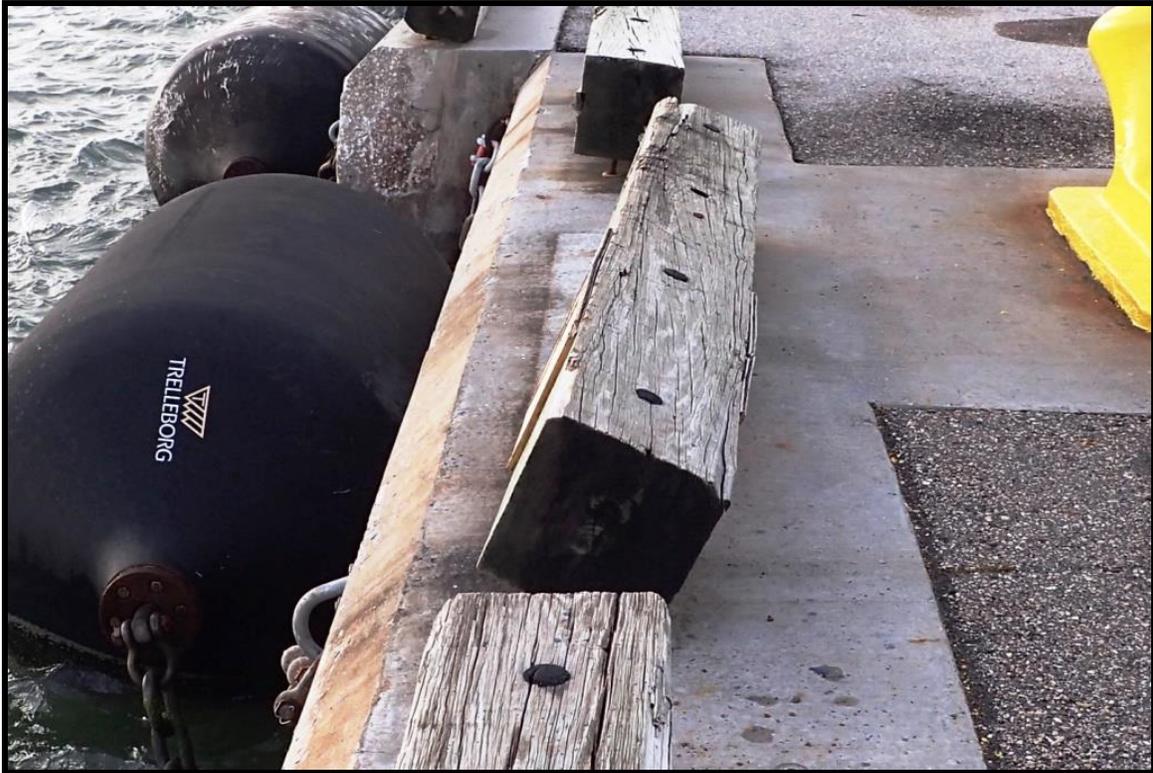
The timber curbs along Berth 1 are in overall Satisfactory condition. However, the timber curbs were missing from Station 4+13 has impact damage (Photo 5). The ship fenders are in overall Fair condition. The lower chain link connections are generally broken from the fender connection hardware and hanging from the fender hardware as a result of heavy corrosion and abrasion. The upper fender chains and connection hardware typically exhibit light to moderate corrosion. The fender chains at Station 2+60 and Station 4+03 are detached (Photo 6) and the ship fender at Station 3+00 is missing (Photo 7).

Photo 5. Station 4+13 timber curb with impact damage

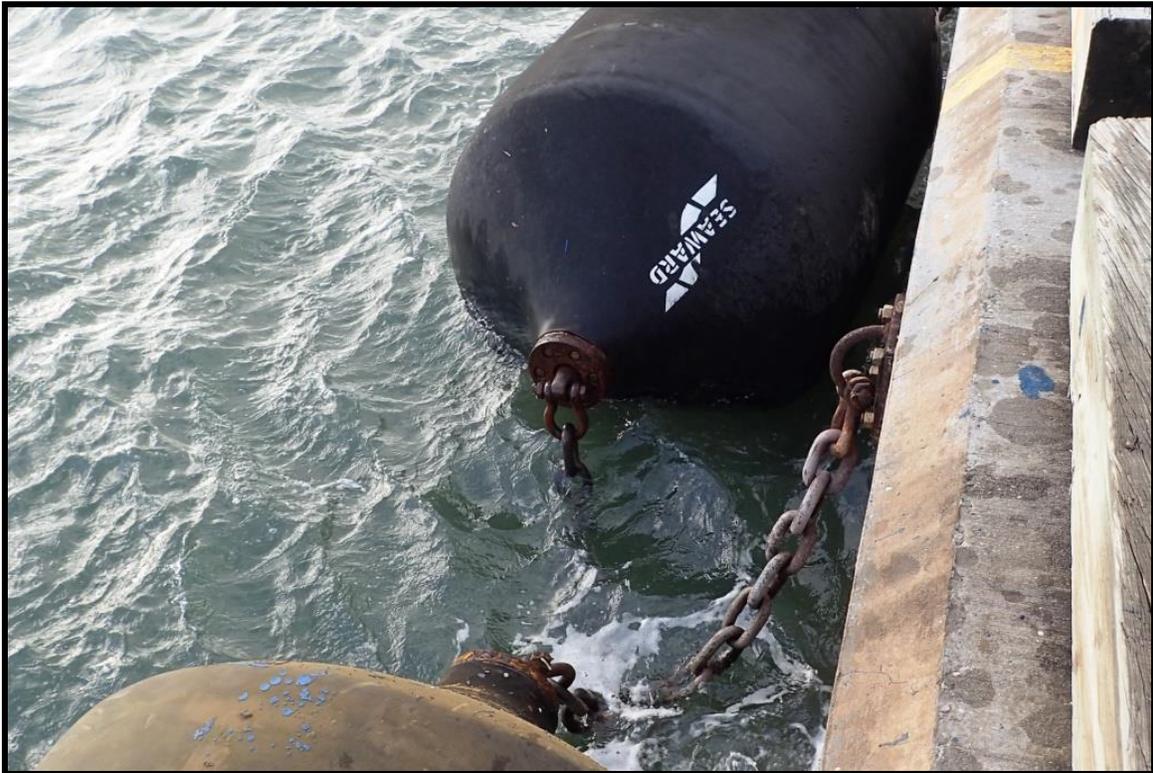
Photo 6. Station 4+03 Ship fender with detached fender chain.

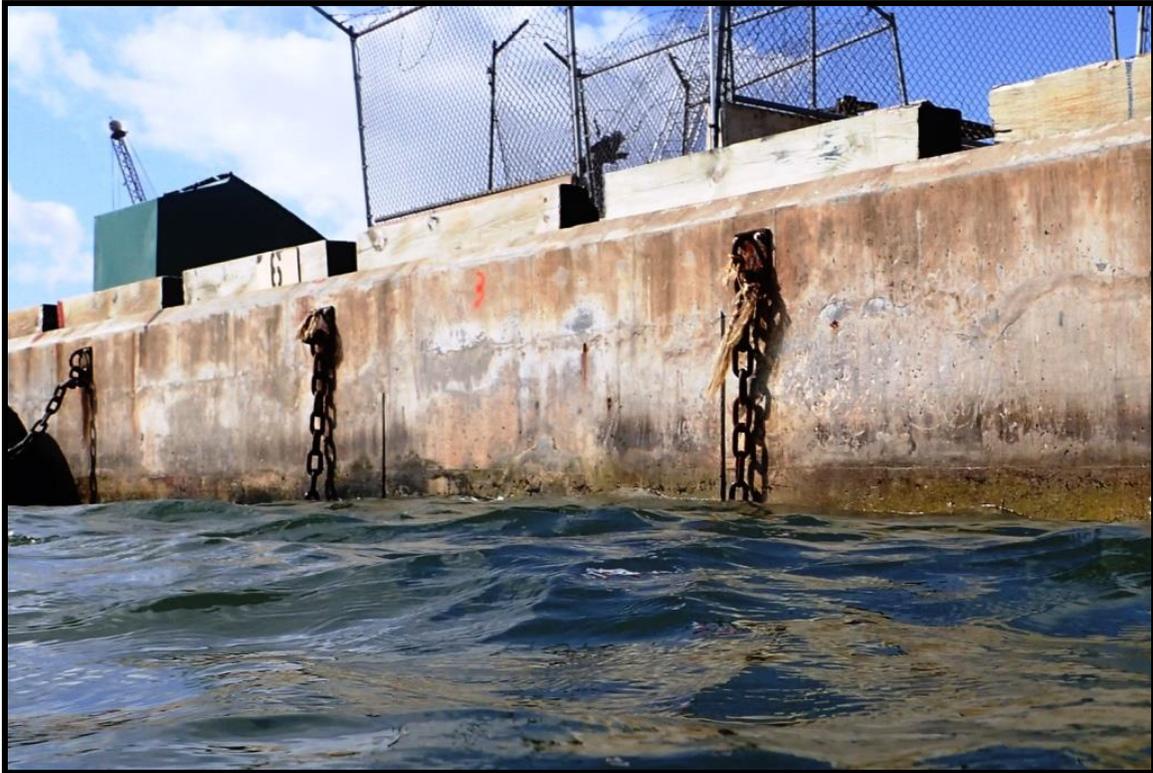
Photo 7. Station 3+00 Missing ship fender.

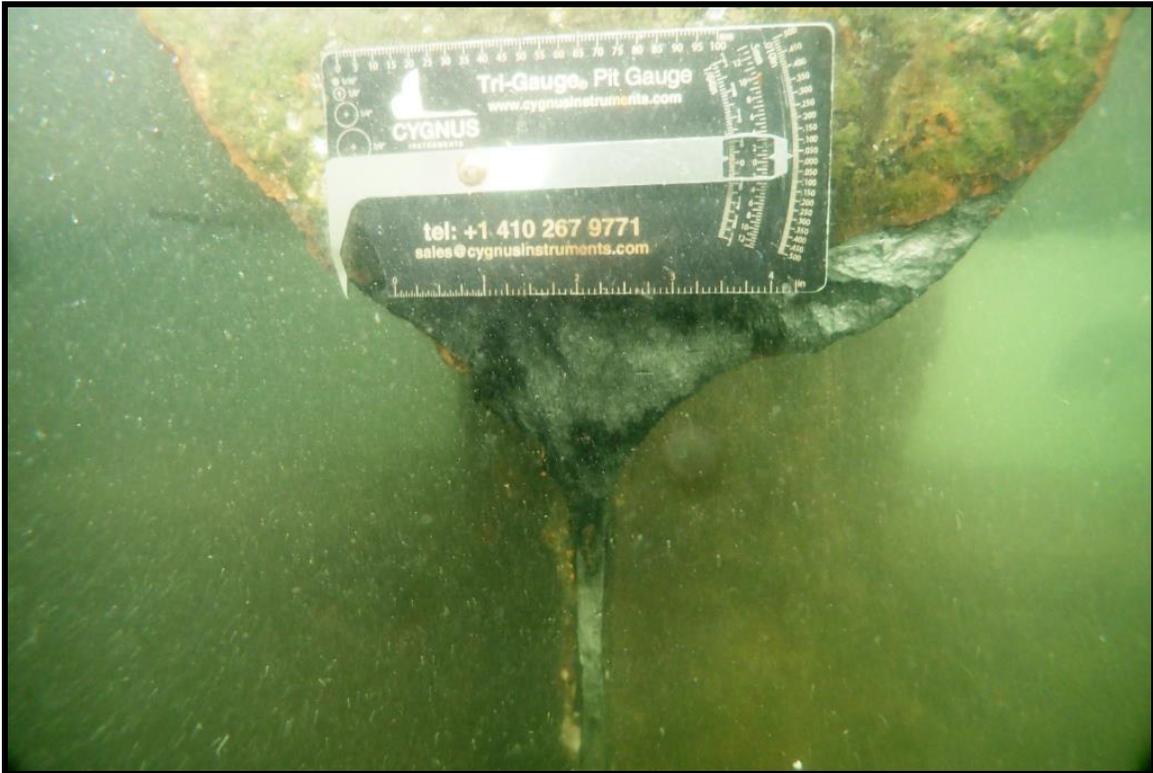
The Prop wash wall is in overall Poor condition. The steel H-piles typically exhibit light corrosion along the flange edges with minor pitting up to 1/16 inch deep. Localized areas exhibited 1/8 inch deep pitting on approximately 5% of the flange faces. However, Piles 1S, 2S, 3S, 4S, 5S, and 10S have severe deficiencies. Refer to Table 3 below for a list of Prop wash wall pile defects. The concrete deck exhibited longitudinal cracks up to 1/18 inch wide with rust staining along the face and soffit. The concrete waffle slabs between the north steel H-piles were intact with no major deficiencies.

<u>Pile No.</u>	<u>Description</u>
1S	Severe corrosion of south flange with 100% missing from Elev. +1 ft to -2 ft. In addition, web was missing 20% (Photo 8).
2S	Severe corrosion of south flange with 100% missing from Elev. +1 ft to -2 ft. In addition, web was missing 20%.
3S	Advanced corrosion of south flange with 25% missing from Elev. +1 ft to -2 ft.
4S	Advanced corrosion of south flange with 25% missing from Elev. +1 ft to -2 ft.
5S	Moderate corrosion of south flange with 10% missing from Elev. +1 ft to -2 ft.
5S	Southwest flange cut out 16 inches high at Elev. -11 ft.
10S	Southwest flange cut out 16 inches high at Elev. -11 ft.

Photo 8. Prop wash wall Pile 1S 100% loss of south flange.

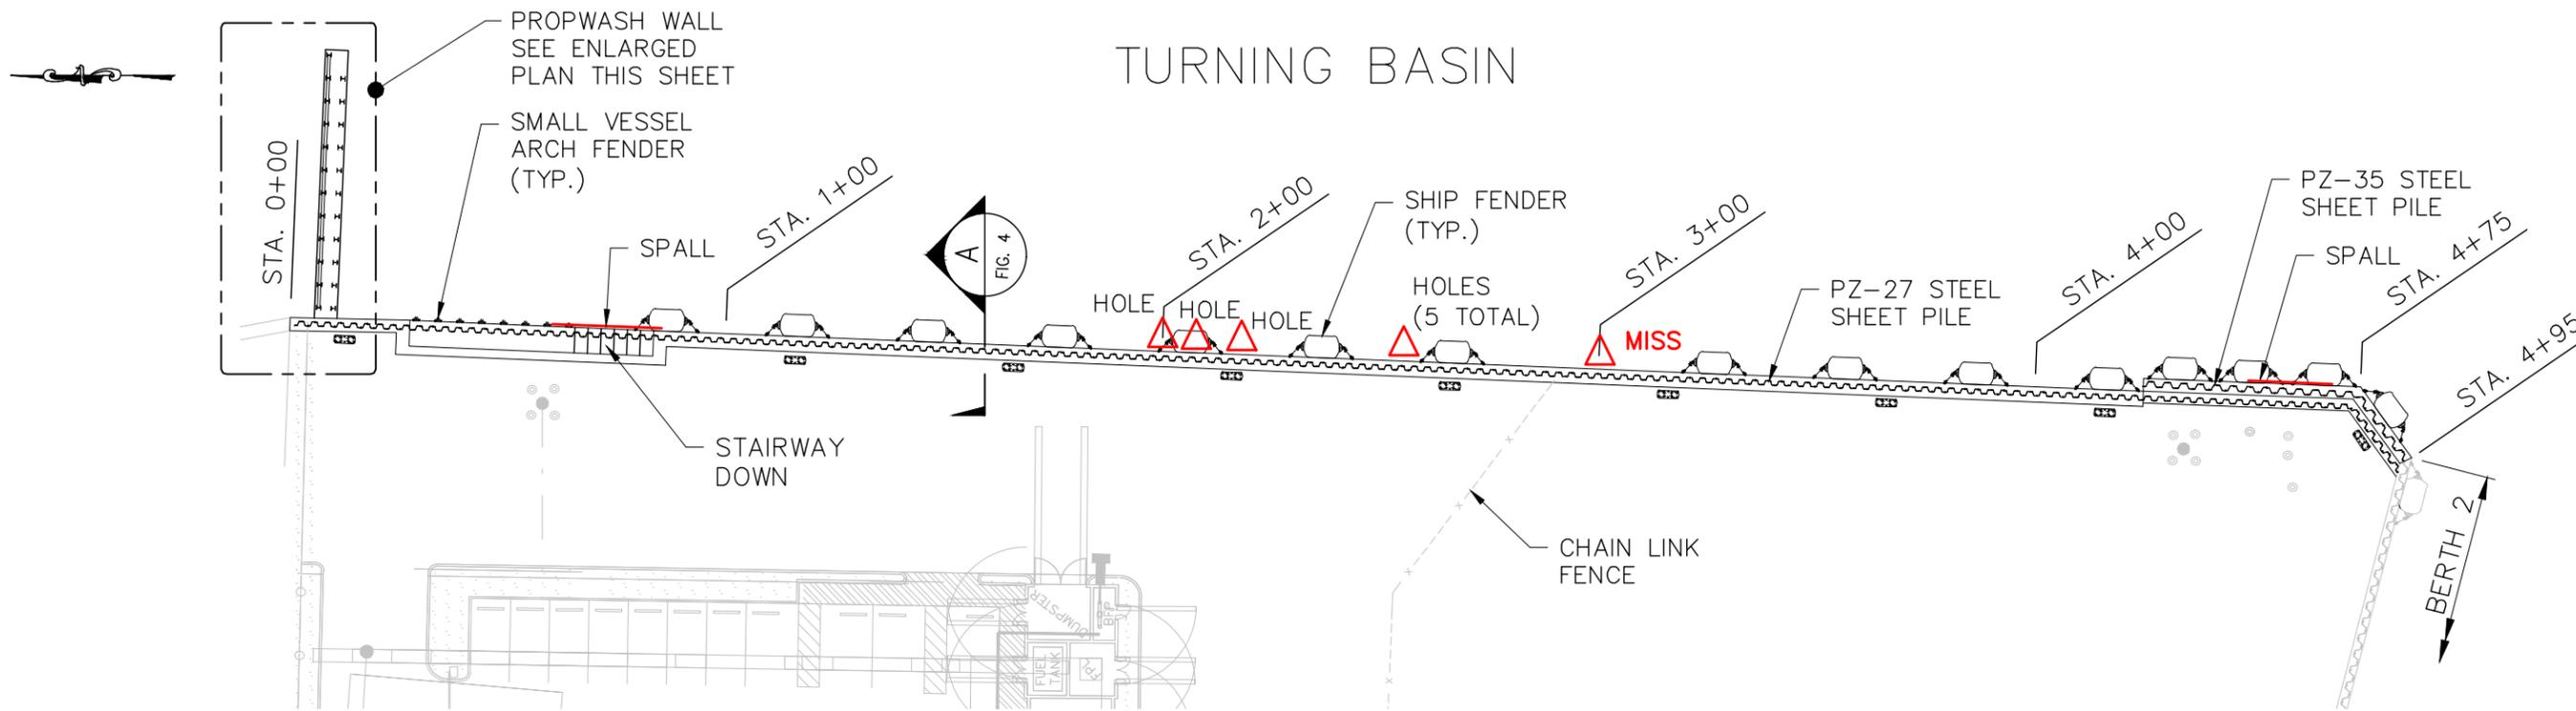
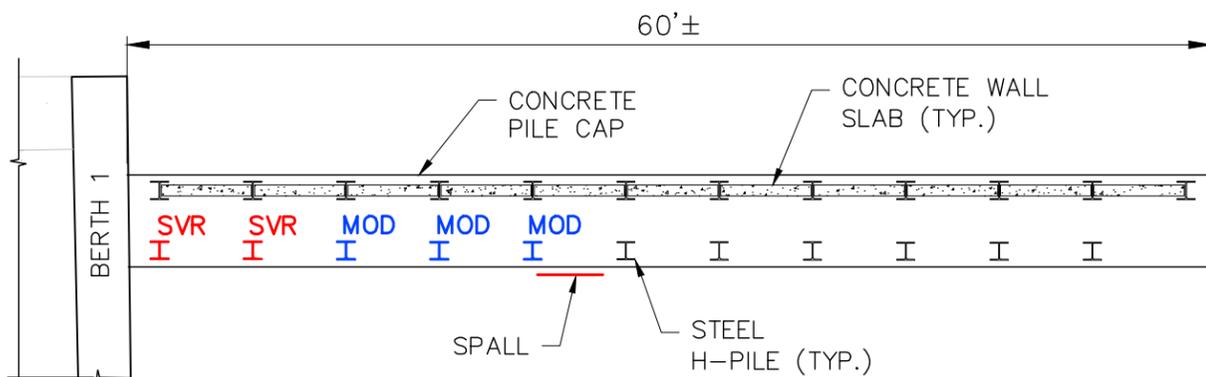
DESIGNED BY	STRUCTURAL CONDITIONS SURVEY PORT OF PALM BEACH DISTRICT RIVERA BEACH, FLORIDA	SCALE	REVISION
DRAWN BY J. PRUITT		DATE	
CHECKED BY	BERTH 1 INSPECTION PLAN	DRAWING NO.	
PROJECT ENGR M. GRICE		FIG 3

Photographs including the typical conditions and deficiencies at Berth 1 are provided in Appendix A. An Inspection Plan including the locations and orientations of the deficiencies at Berth 1 are presented on Figure 4 and provided in Appendix B.
